MODEL 60/65/67 WALL HYDRANTS TROUBLESHOOTING AND MAINTENANCE

INSTRUCTIONS FOR USING MODEL 65/67 PLUNGER REMOVAL TOOL

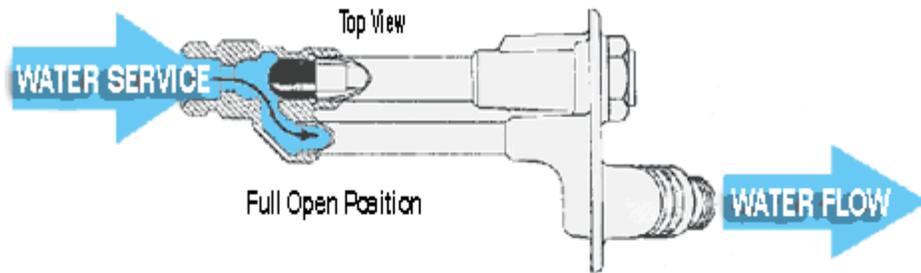
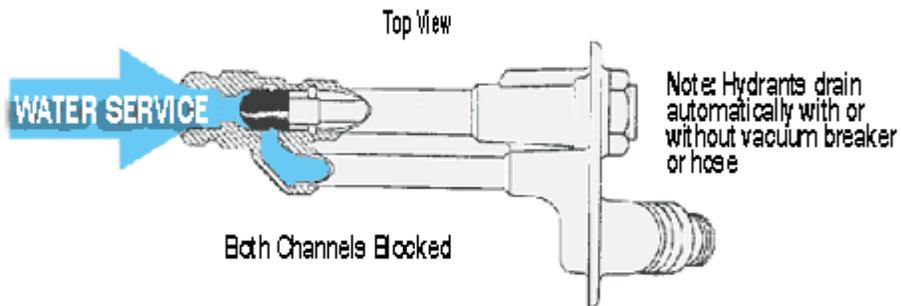
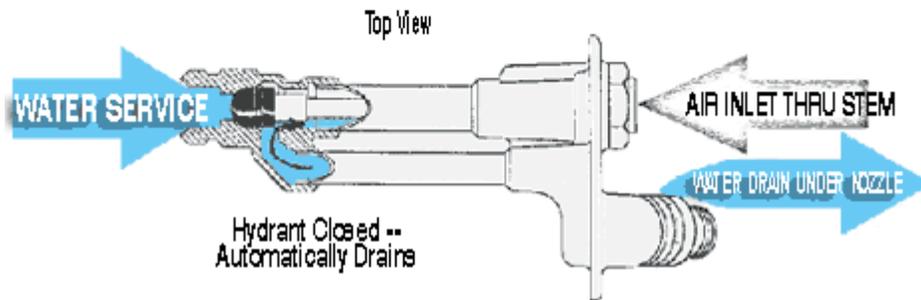
With the operating rod removed, screw the removal tool into the center of the plunger rubber until the corkscrew is all the way through the rubber.

Clamp a vise grip pliers about 1" from the face of the hydrant. Using a small pry bar, pry against the vise grips, pulling straight and smooth. Relocate the vise grips as necessary. If the tool pulls loose from the plunger rubber, repeat the process.

Make sure all rubber pieces are removed before replacing the new parts.
