# Vero™ Tub/Shower Trim

Models/Modelos/Modèles T14253-H2O & T14453-H2O Series/Series/Seria

## Cartridge Summary Reference Sheet

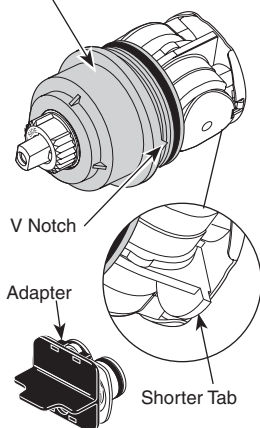
17

Grey Upper Cap

Order RP46463 to Replace Cartridge.

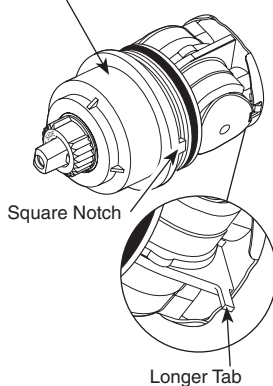
1700

White Upper Cap

Order RP32104 to Replace Cartridge.
