Crown® Flushometer

Crown® II (Obsolete)

Manual Flushometers

PARTS LIST

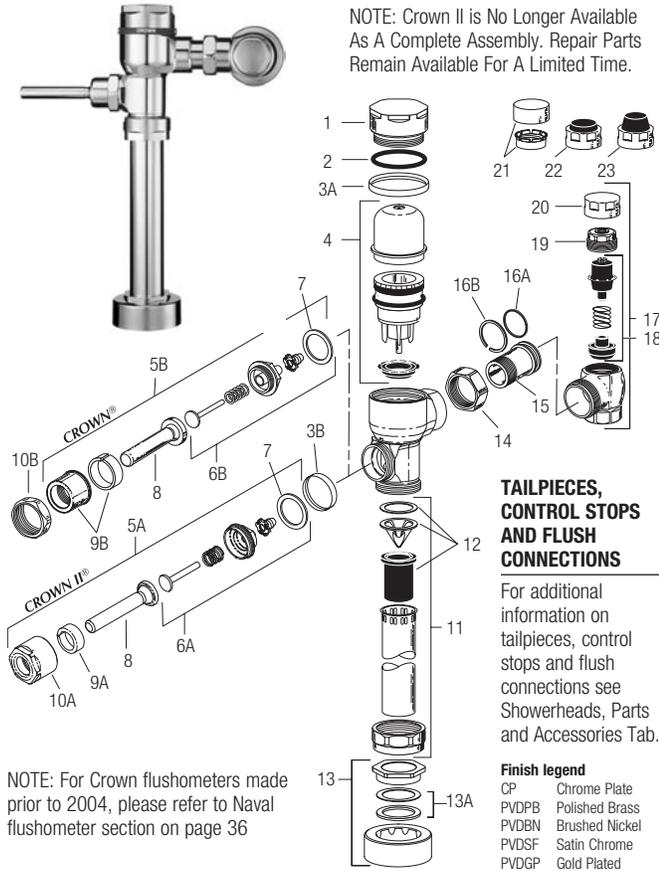
Item No.	Code No.	Part No.	Description
1.	0332006	CR-116	CP Cover
2.	0332030	CR-133	Cover O-ring
3.	0332045	CR-132-A	CP Handle and Cover Trim Ring Kit (Includes items 3A & 3B) (CROWN® II ONLY)
	0332046	CR-132-A	PVDPB Handle and Cover Trim Ring Kit (Includes items 3A & 3B) (CROWN® II ONLY)
	0332048	CR-132-A	PVDBN Handle and Cover Trim Ring Kit (Includes items 3A & 3B) (CROWN® II ONLY)
	0332049	CR-132-A	PVDSF Handle and Cover Trim Ring Kit (Includes items 3A & 3B) (CROWN® II ONLY)
3A.	0332035	CR-134	Cover Trim Ring (CROWN® ONLY)
	0332009	CR-120	PVDPB Cover Trim Ring (CROWN® II ONLY)
	0332032	CR-120	PVDGP Cover Trim Ring (CROWN® II ONLY)
	0332033	CR-120	PVDBN Cover Trim Ring (CROWN® II ONLY)
	0332034	CR-120	PVDSF Cover Trim Ring (CROWN® II ONLY)
3B.	0332005	CR-113	PVDPB Handle Trim Ring (CROWN® II ONLY)
	0332028	CR-113	PVDBN Handle Trim Ring (CROWN® II ONLY)
	0332029	CR-113	PVDSF Handle Trim Ring (CROWN® II ONLY)

4.	3332003	CR-1004-A	Piston Kit – 1.6 gpf (6.0 Lpf) Water Closet
	3332013	CR-1011-A	Piston Kit – 1.28 gpf (4.8 Lpf) Water Closet
	3332004	CR-1005-A	Piston Kit – 1.0 gpf (3.8 Lpf) Urinal
	3332005	CR-1006-A	Piston Kit – 0.5 gpf (1.9 Lpf) Urinal
	3332017	CR-1015-A	Piston Kit – 0.25 gpf (1.0 Lpf) Urinal
	3332016	CR-1014-A	Piston Kit – 0.125 gpf (0.5 Lpf) Urinal

ALL PISTON KITS INCLUDE MAIN SEAT (see item 4 table to right) AND CR-124-A INSIDE COVER ASSEMBLY AS SHOWN IN ITEM 4. PISTON KIT COMPONENTS TABLE TO THE RIGHT.

ITEM 4. PISTON KIT COMPONENTS

Item	Code No.	Part No.	Description
A.	***	CR-124-A	Inside Cover Sub-Assembly
B.	***	***	Piston Cover
C.	5332095	CR-68-A	Molded Cup – 12/pkg
D.	5328019	SH-406	Spring – 12/pkg
E.	***	***	Relief Valve
F.	0307116	G-95	Relief Valve Seat
G.	***	***	Piston Body
H.	***	CR-125-A	Main Seat – 6/pkg (1.0 gpf)
	***	CR-170-A	Main Seat – 6/pkg (0.125 gpf, 0.25 gpf and 0.5 gpf)
I.	0307210	G-85	Filter O-ring
J.	0332124	CR-169	O-ring (for use with CR-125-A main seat ONLY)*
	5308958	H-589	O-ring* 6/pkg
